# WROUGHT IRON *for* UNDERGROUND SERVICES

A TECHNICAL BULLETIN PREPARED BY THE ENGINEERING SERVICE DEPARTMENT

**A. M. BYERS COMPANY • PITTSBURGH, PA.**

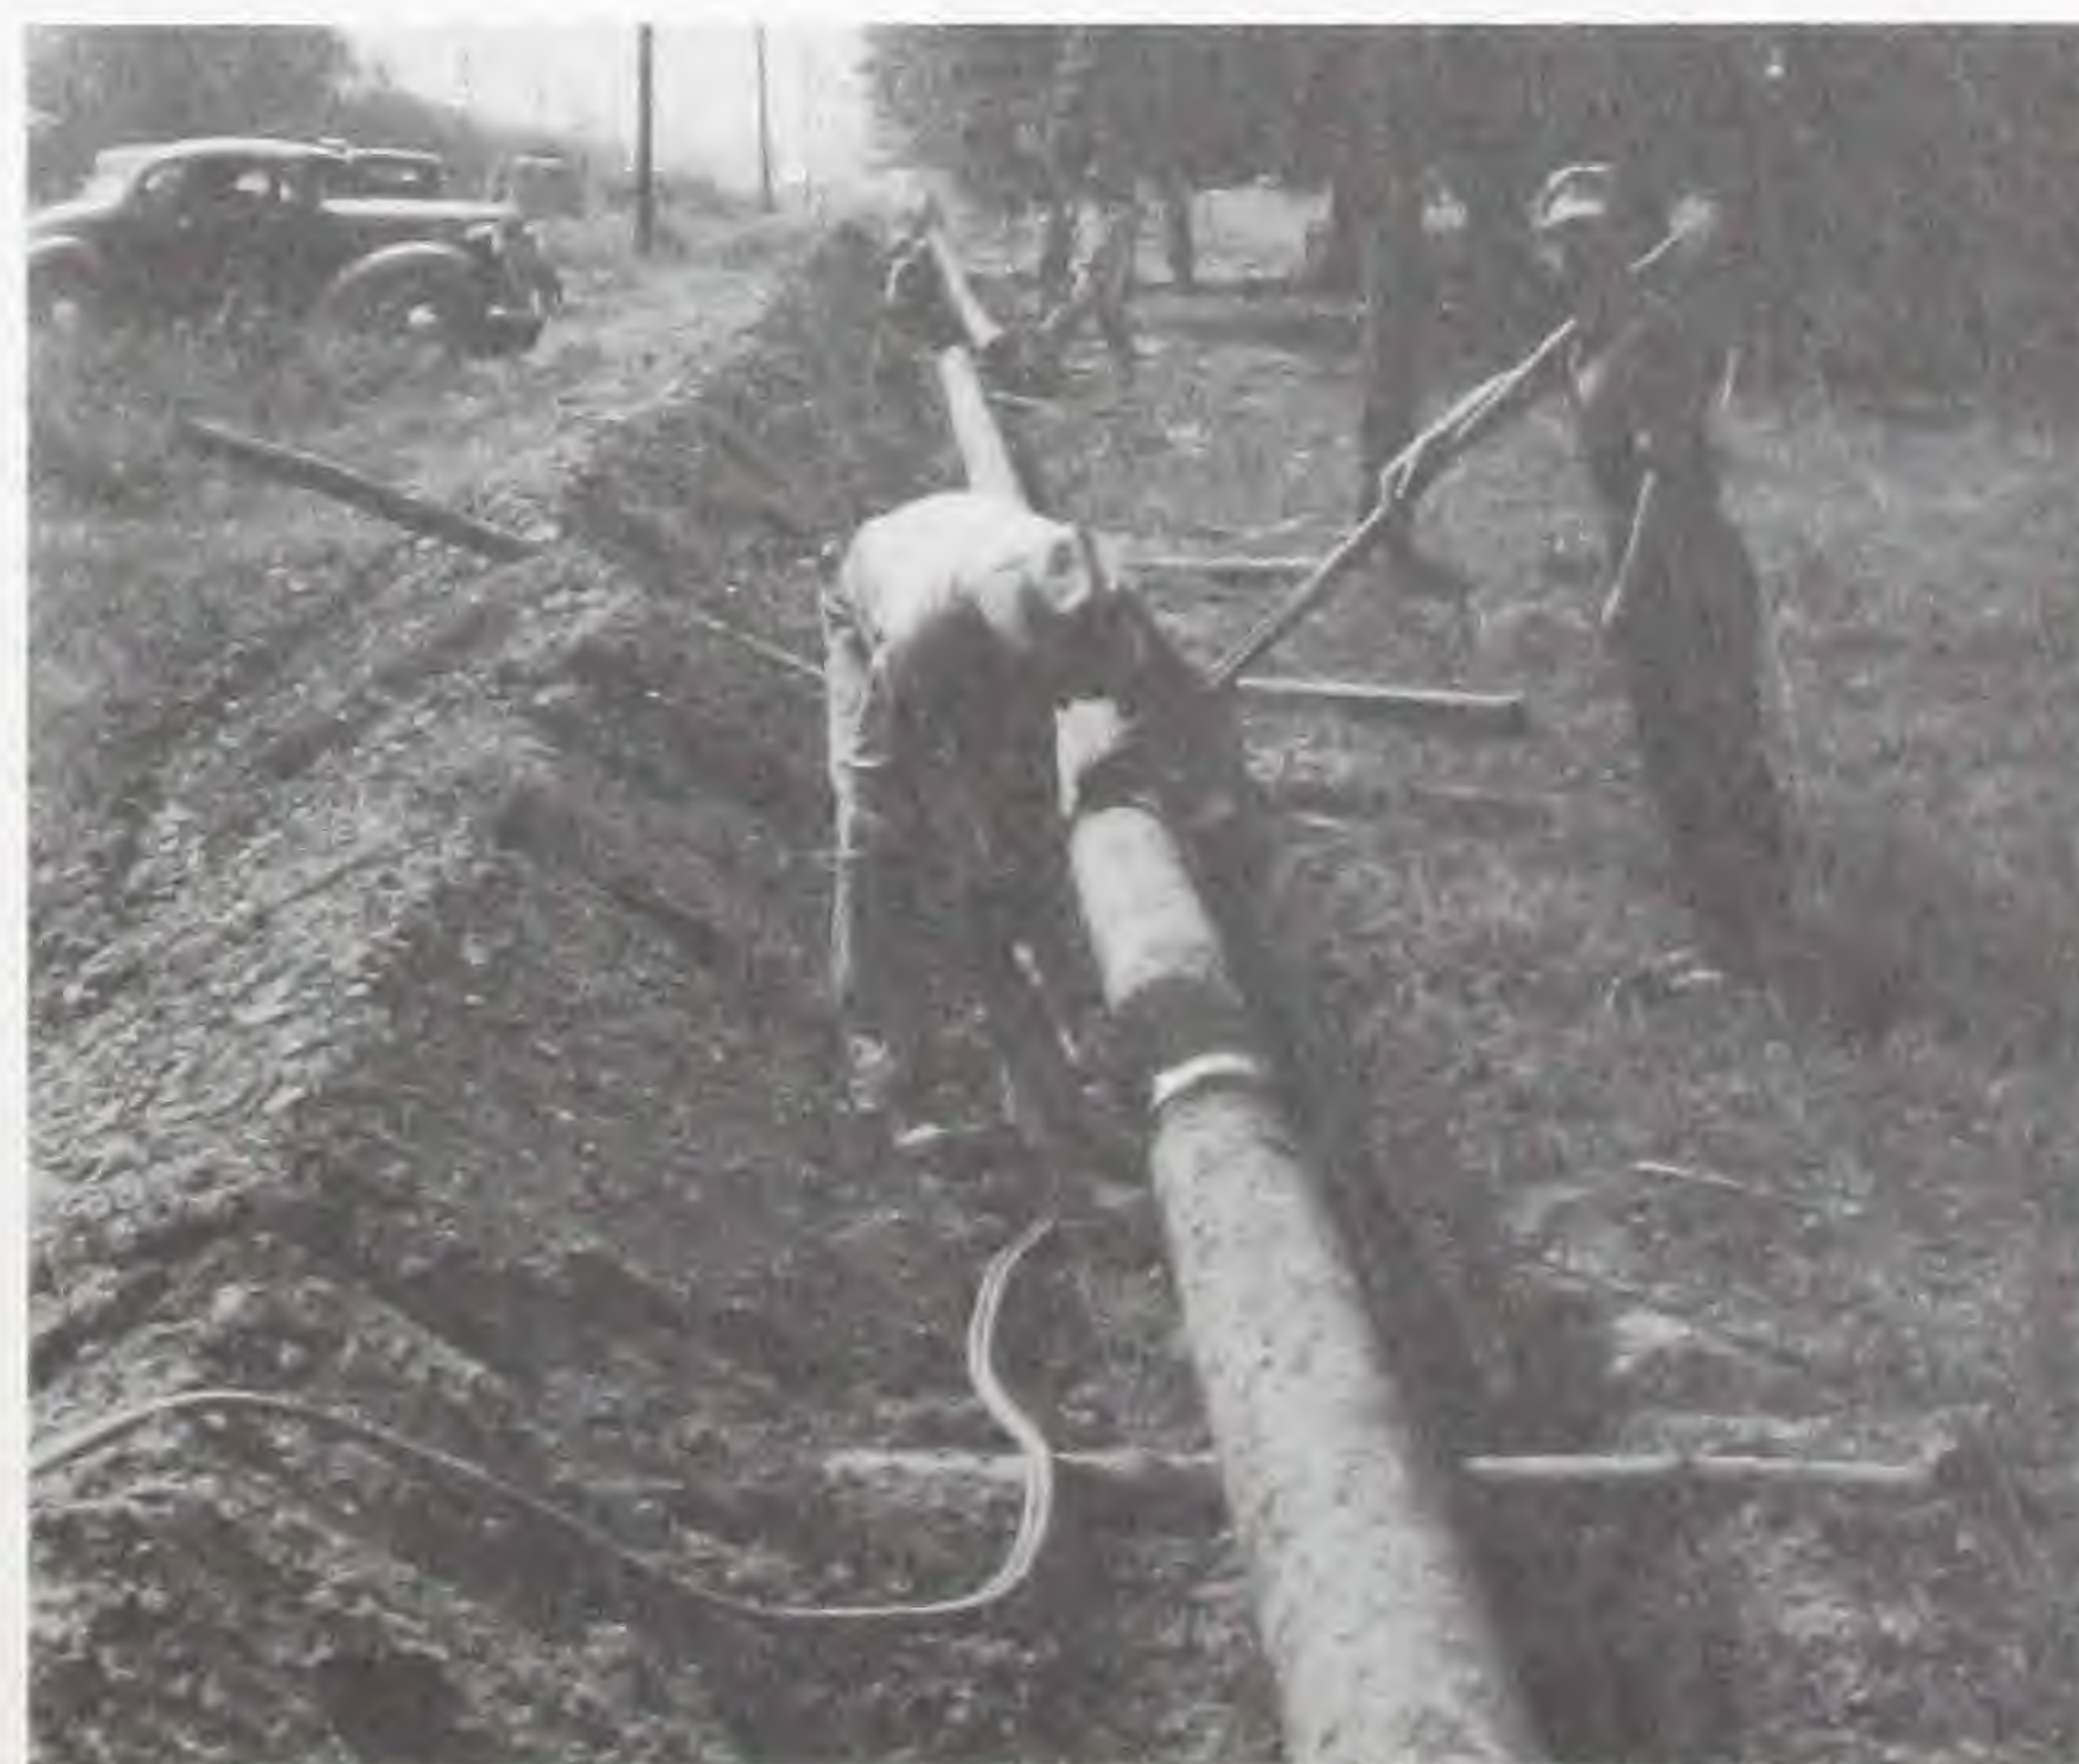
Fig. 29

When the wrought iron line was 26 years old, it was paralleled by a steel line, in order to obtain increased carrying capacity. The steel has already failed, and has been replaced, after having been in service less than half the number of years the wrought iron was buried in the same location.

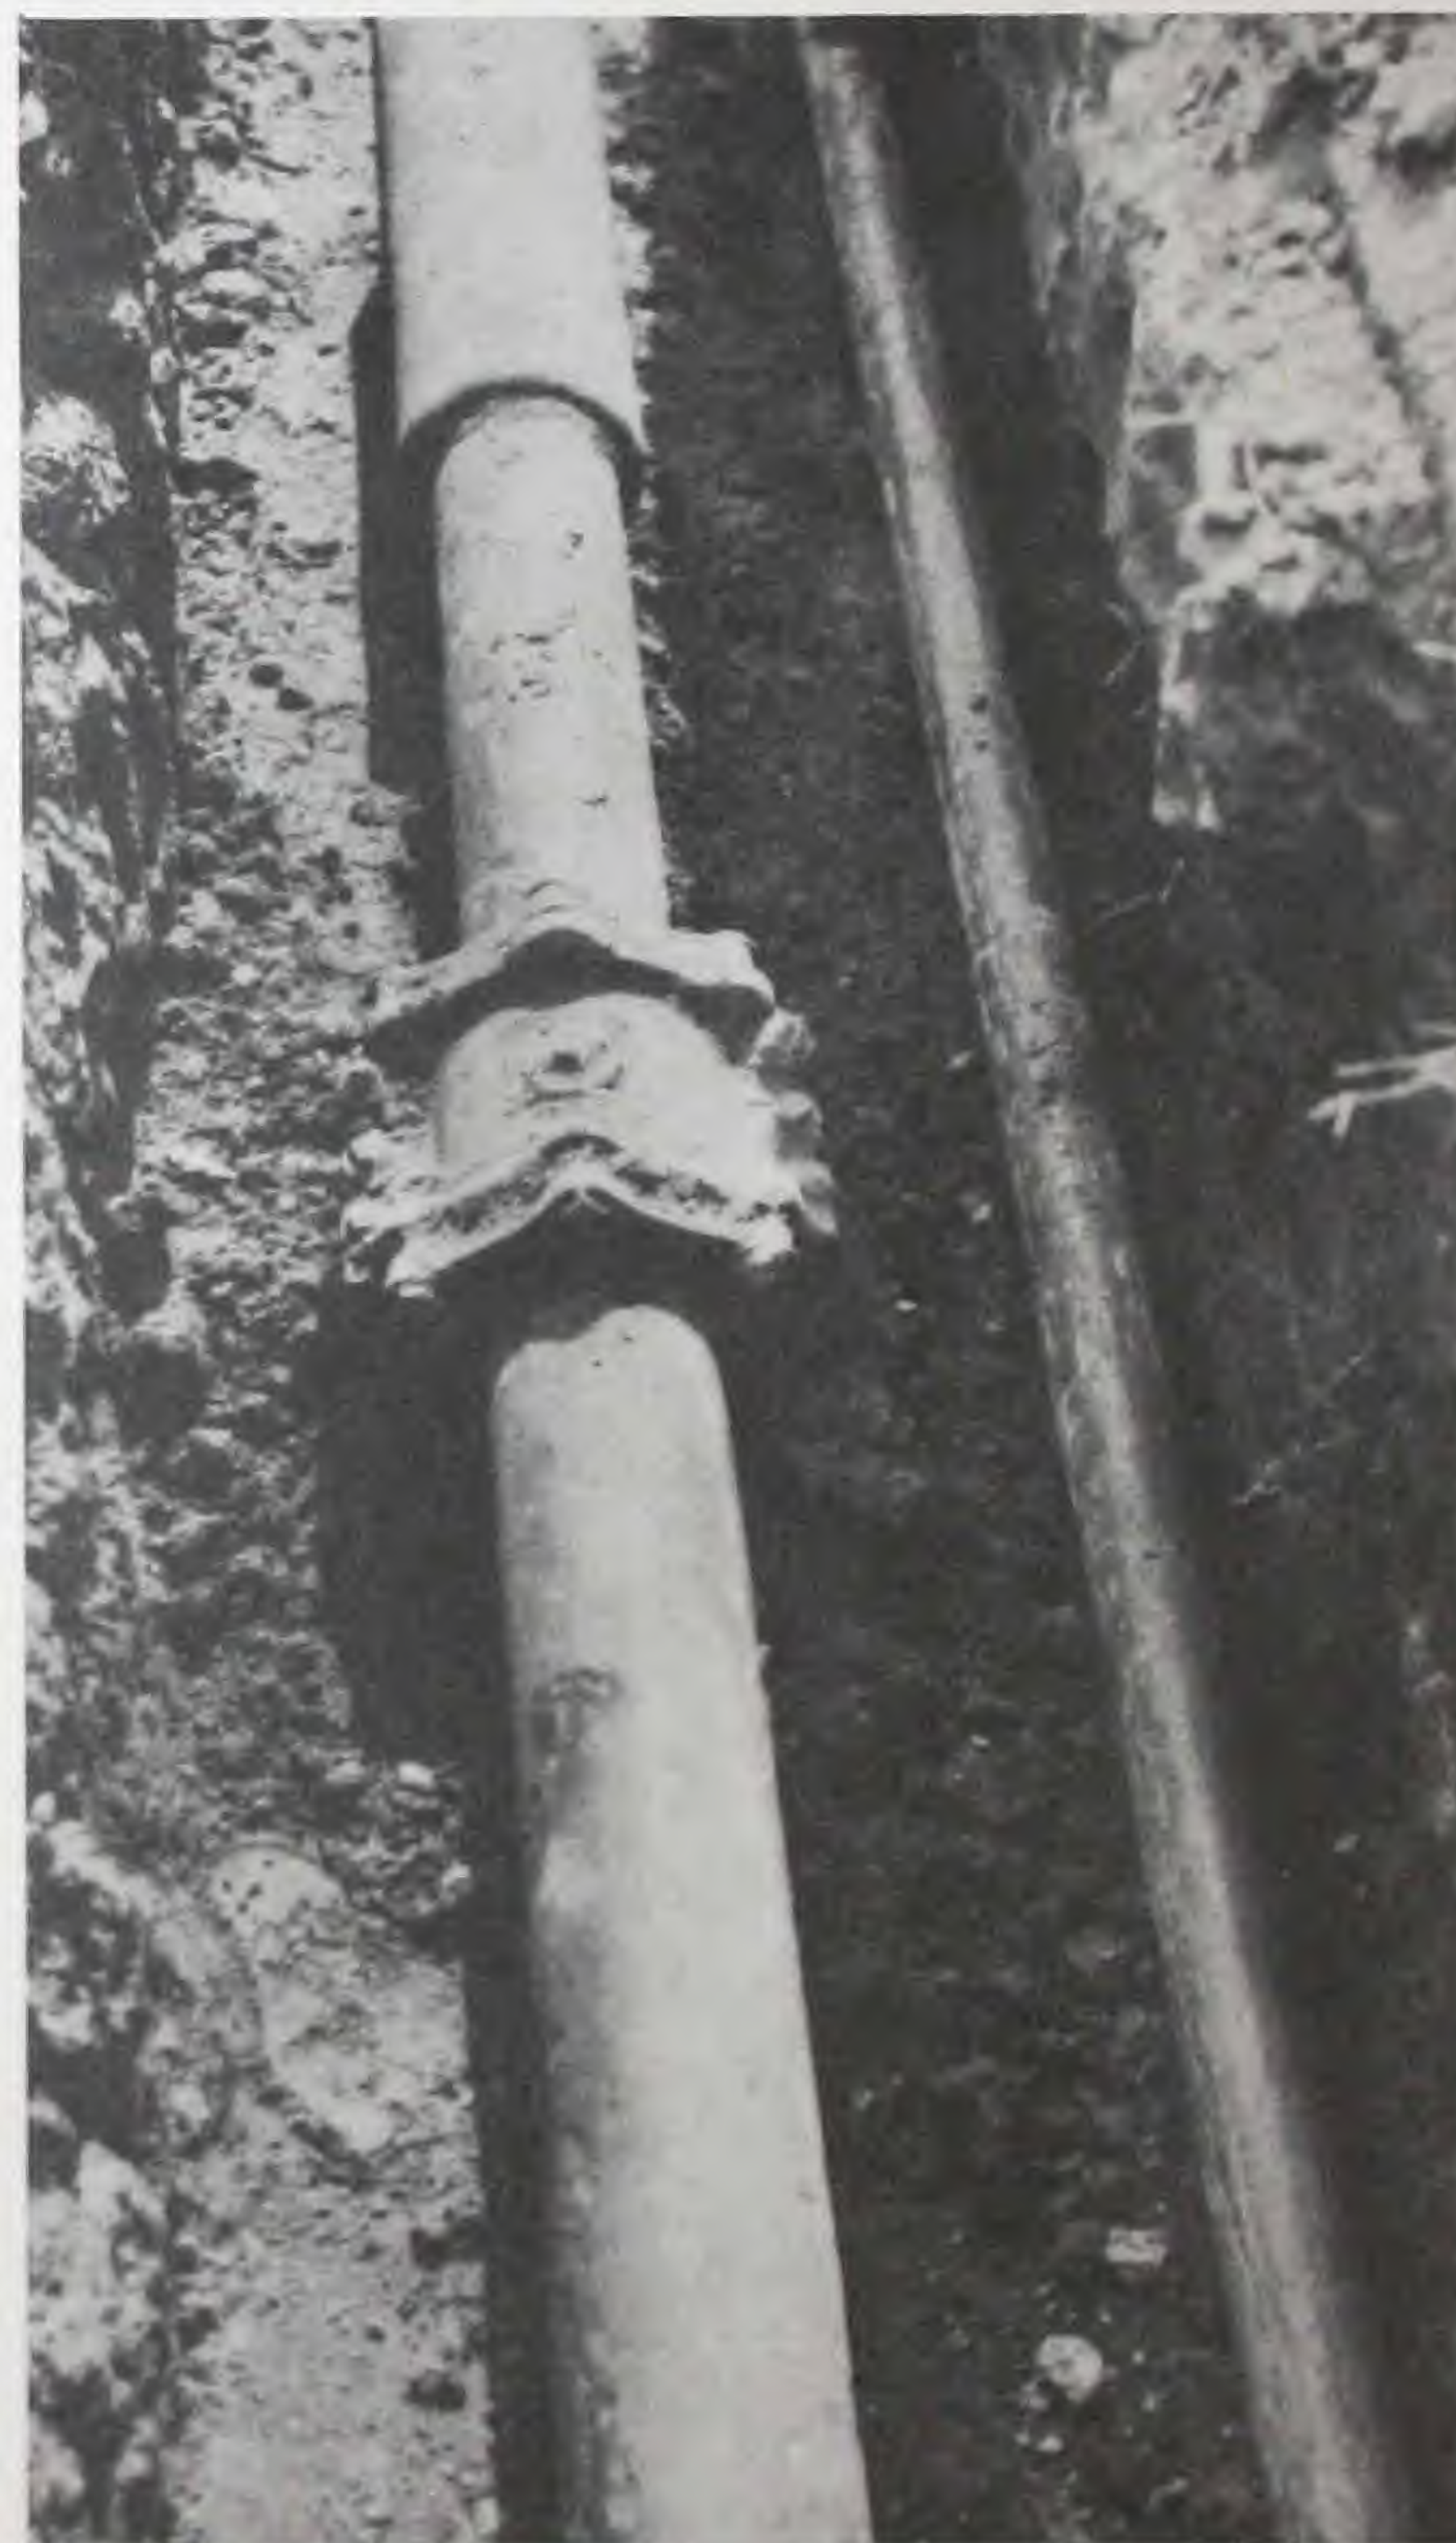
In Moorestown, New Jersey, one of the first so-called "high pressure" gas lines (15#) was laid along Chester Avenue. Three-inch wrought iron pipe was used without any coating. When the Camden-Trenton main was laid the Moorestown line was connected to it. After 29 years, need for increased capacity made it necessary to parallel the old line with 6" pipe, and coated steel was used. The steel had been in only about 15 years when leaks began killing trees, and Fig. 30 shows the 44-year-old 3" wrought iron (right) and the 15-year-old 6" steel pipe at that time. The wrought iron was wire-

brushed for a distance of 1000 ft., and no pits as large as  $\frac{1}{8}$  inch in diameter could be found. Pits in the steel in the same trench can easily be seen in the photograph. One thousand feet of steel pipe were replaced, while the wrought iron remained in service.

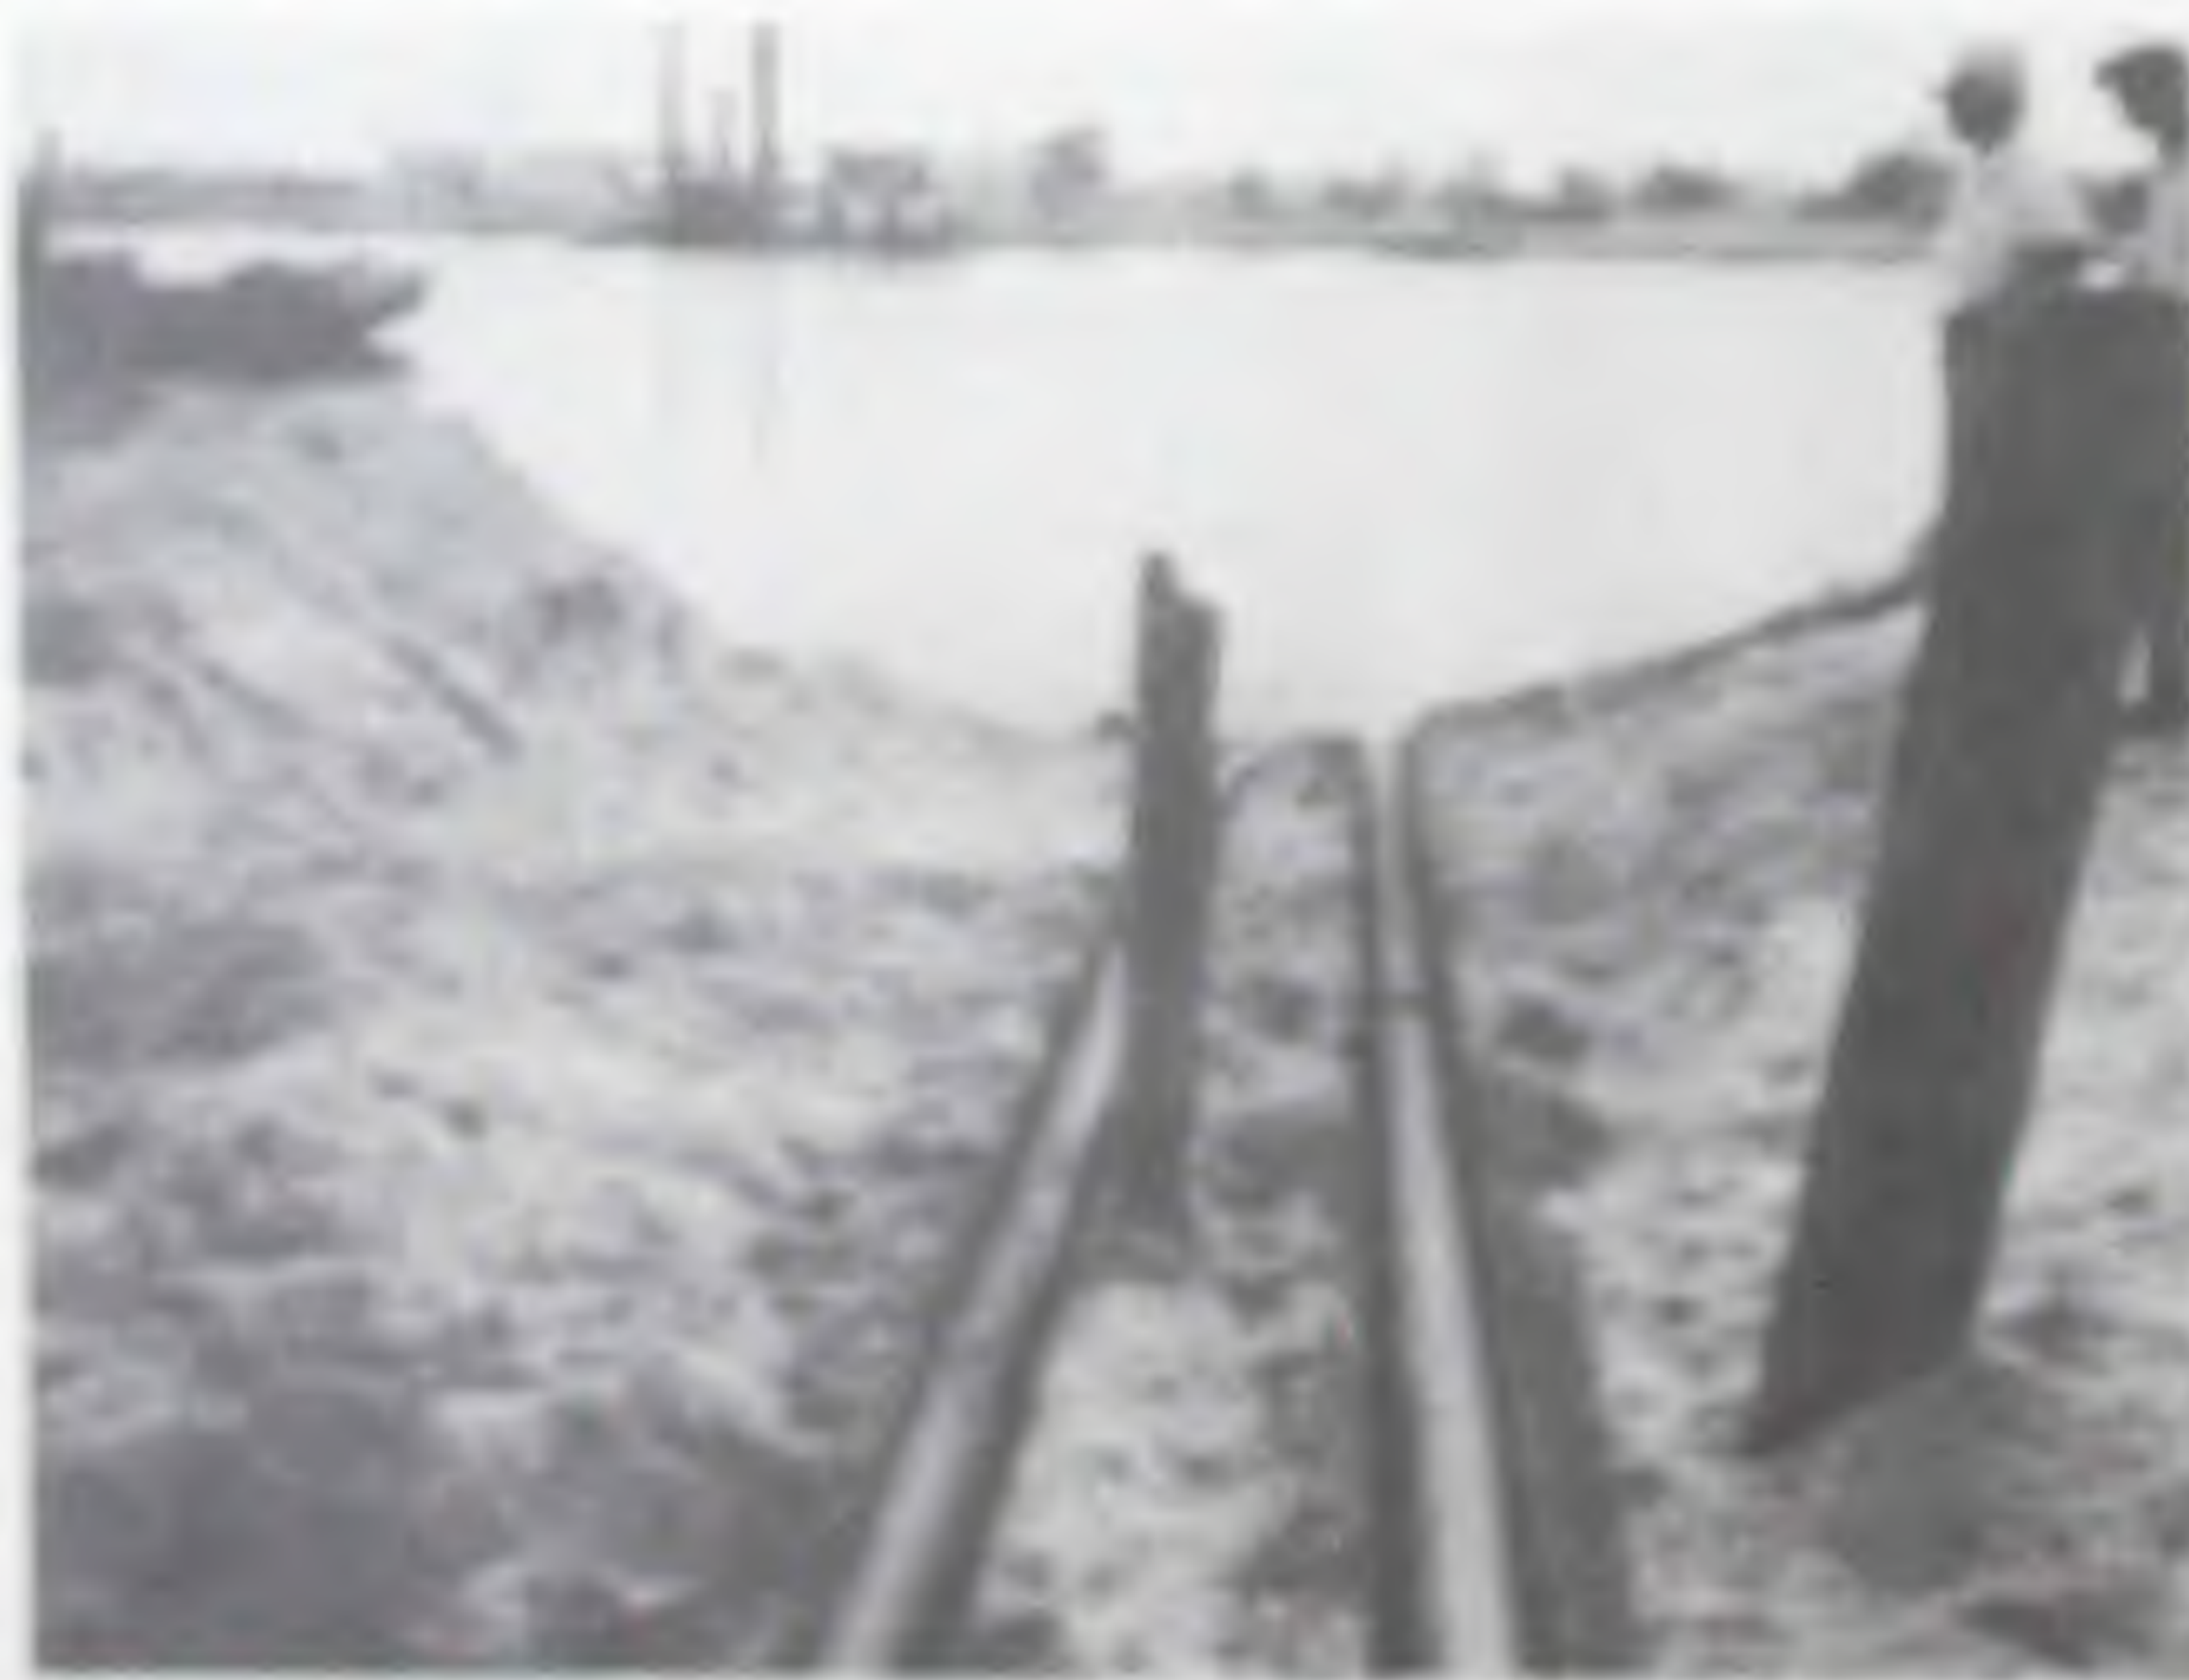
Fig. 32 shows two lines of 6" wrought iron pipe, with welded joints, being installed near Houston, Texas. They cross the Houston Ship Channel and lie in a trench eleven feet deep dredged in the bottom of the channel. Galveston Bay, an arm of the Gulf of Mexico, lies adjacent to the body of water shown in the photograph, and so the pipe is exposed to the corrosive action of soil saturated with sea water.<sup>11</sup>

Two steel lines, formerly used, failed after 8 and 10 years service, respectively, and were removed. The wrought iron lines have been in service over nine years, and according to the Division Superintendent in charge, they have never given any trouble at all.

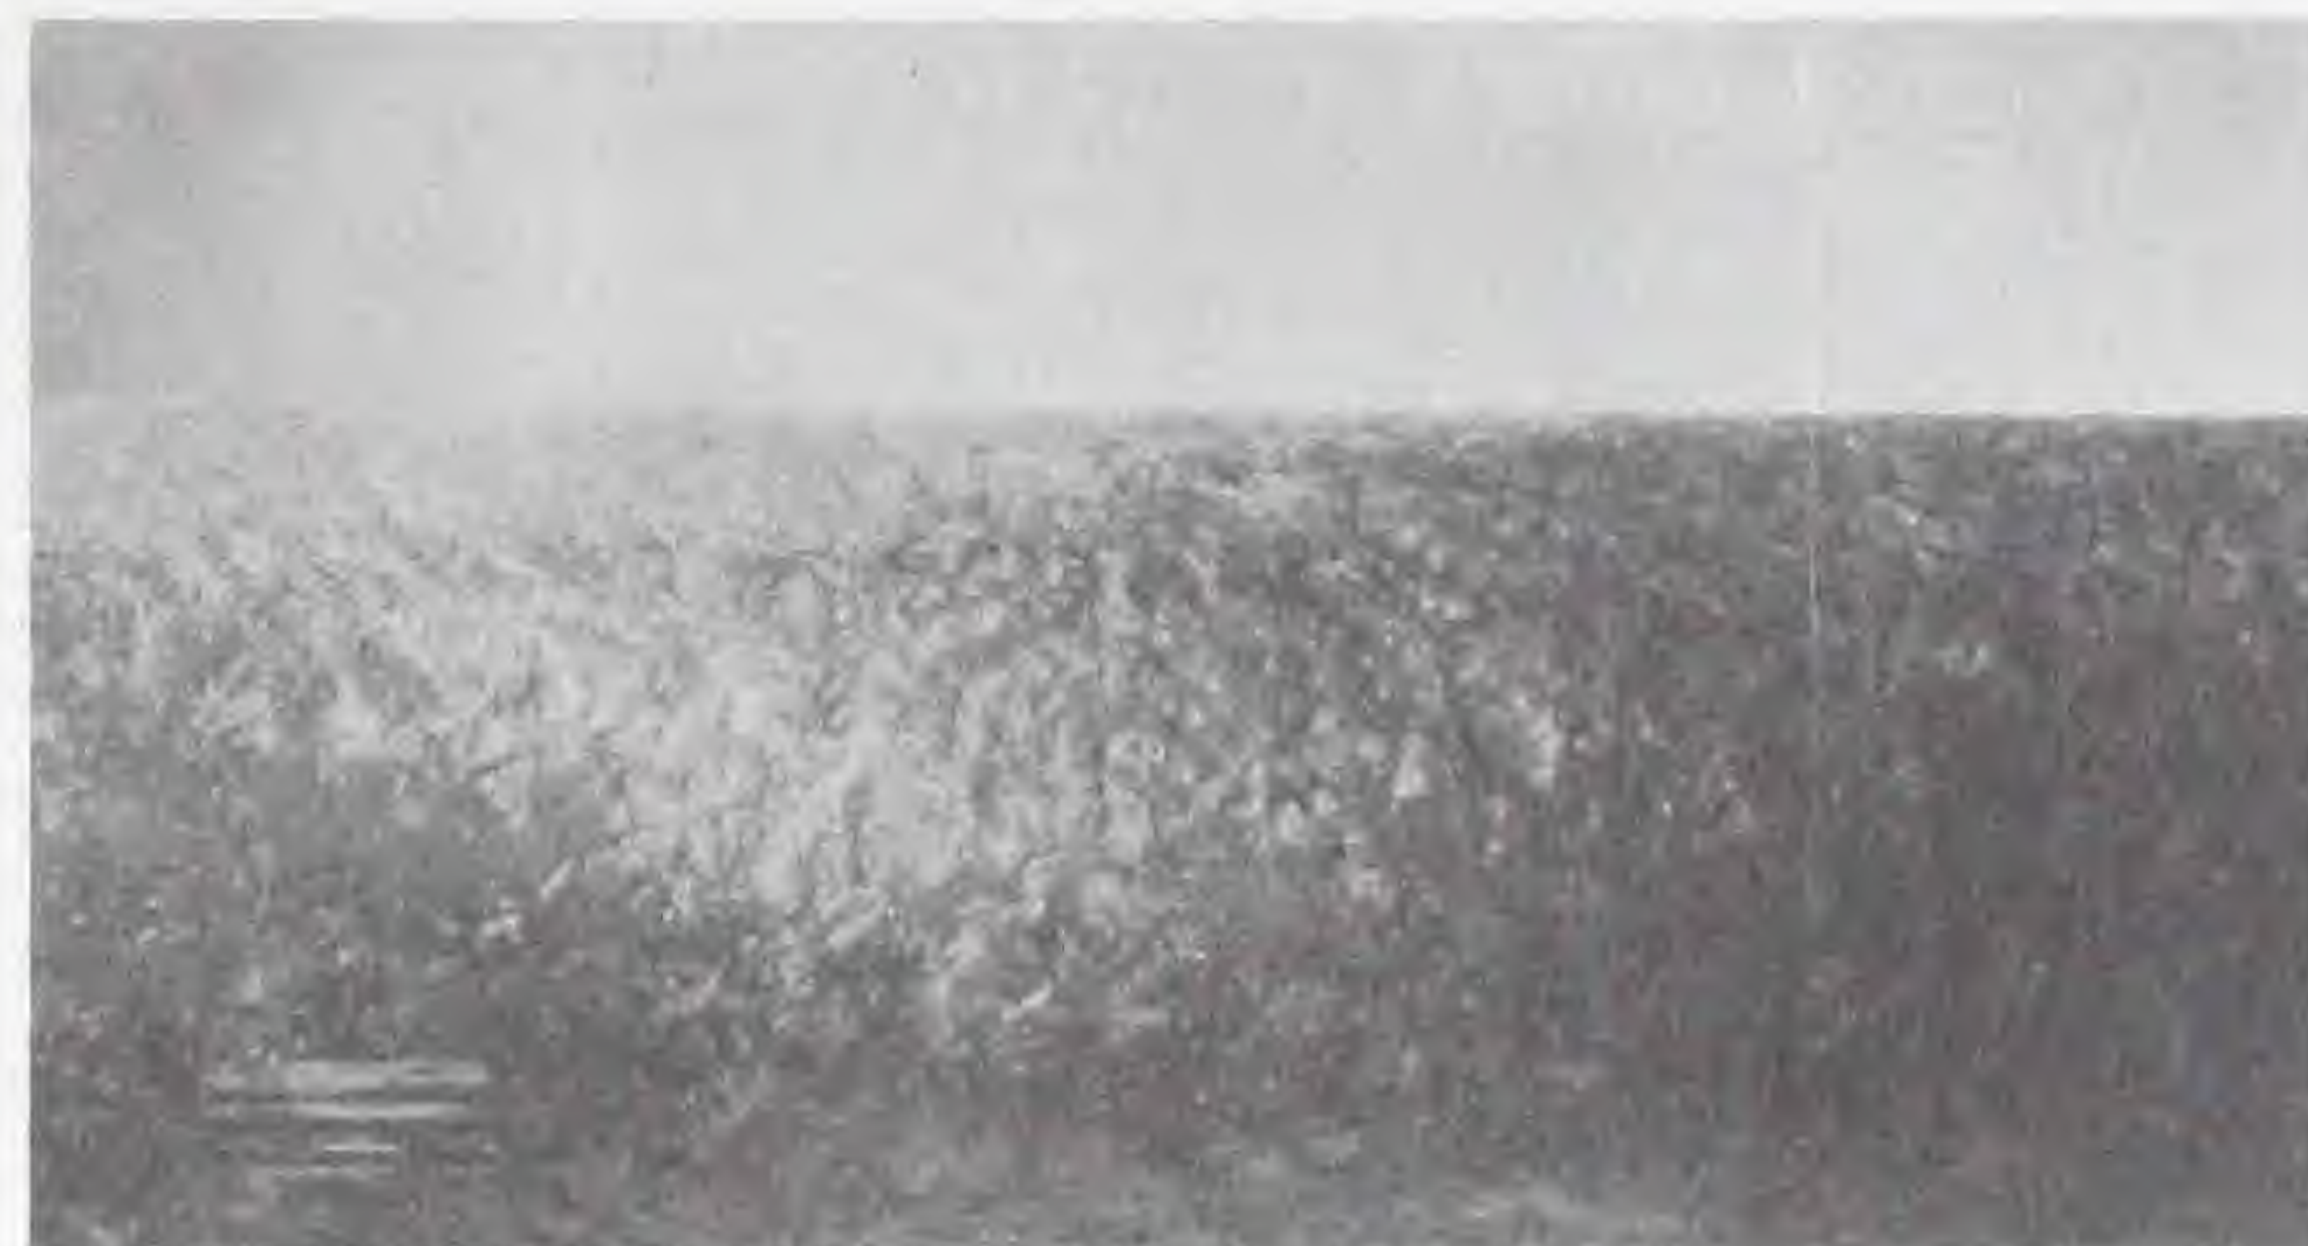
Farther on in the same report, a photograph reproduced as Fig. 34 was included. It shows the broad, shallow, over-all type of corrosion typical of that which forms on genuine wrought iron under most conditions of soil exposure.

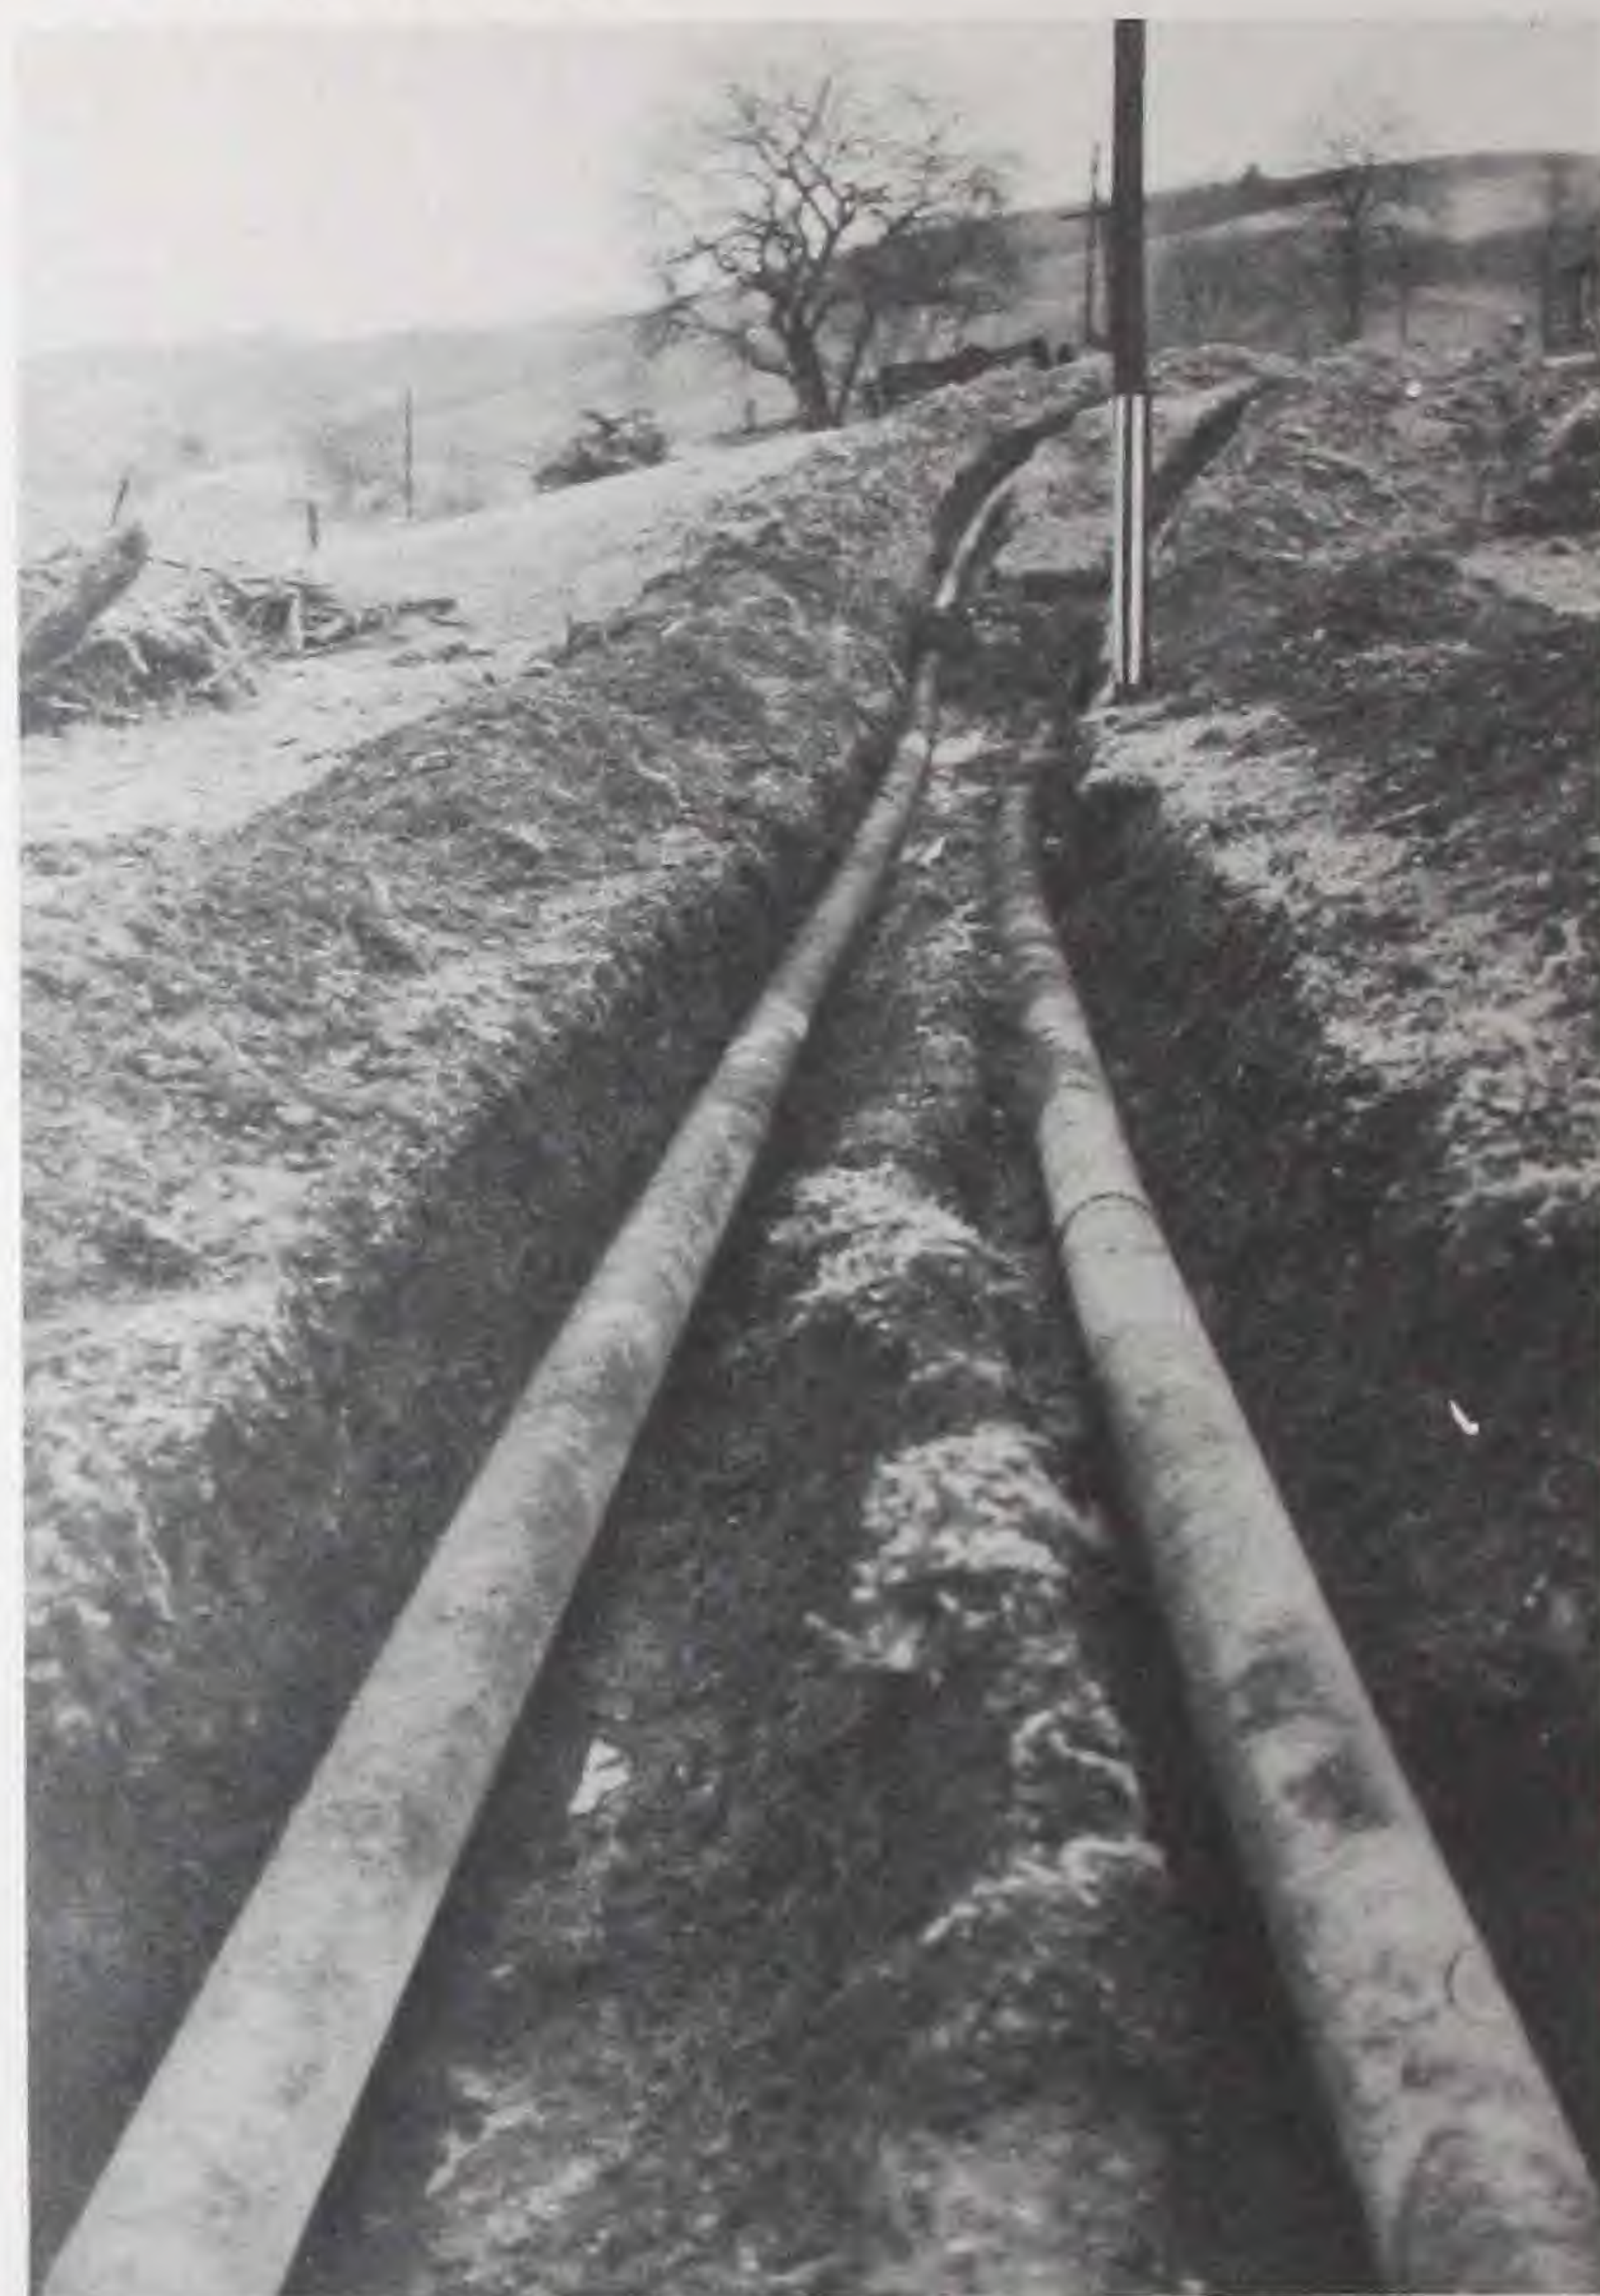
One of the pipe line companies in the Eastern U. S. has, for over half a century been operating a line of 6" wrought iron pipe about 120 miles long. When the wrought iron line was 30 years old, a parallel line of 6" steel pipe was laid. Fig. 35 shows the two lines when a section was re-located several years ago.

Records of leaks in these two lines provide an excellent indication of the superiority of wrought iron over steel under identical conditions. In the 24 year period following the installation of the steel pipe, 45 leaks directly attributable to corrosion occurred. During the same 24 year period, the wrought iron developed only 28 leaks. Thus, while the wrought iron was over twice as old as the steel at the end of the test, only a little over
